What is CONDENSTOP®

CondenStop®
Corrosion Resistance Sheet
agwaymetals.com

DC2116/1
Cyclic Corrosion Testing of the Condenstop Product

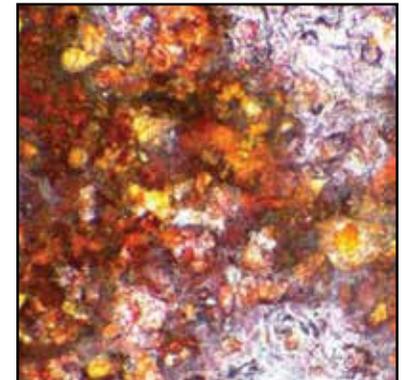
Figure 1. Detailed surface morphology of uncovered steel sample after 500 cycles.

After 500 cycles, the non-covered steel samples showed relative large red iron-rich rust spots, viewing under the optical microscopic further revealed many very small rust-like features. These typical corrosion characteristics were rarely observed on the steel samples covered with CONDENSTOP. The salt coated steel samples directly exposed to the lab atmosphere were heavily corroded as shown in figure 2; the surface morphology of the mild steel sample showed that red-brown, iron-rich, rust covered the whole surface. The salt coated steel samples covered with CONDENSTOP however, while also corroded, showed significantly less oxidization than the bare samples, as shown in figure 3.

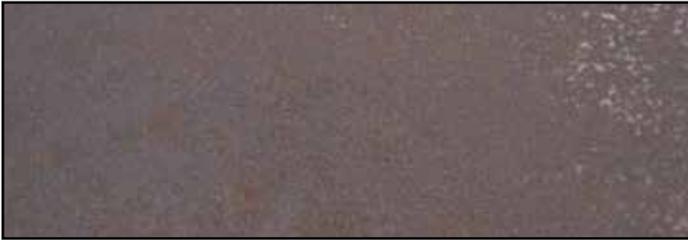
Figure 2. Salt coated steel sample after 500 cycles.

After 250 cycles, the non-covered steel samples showed several small red rust spots on the surface. The steel samples that were covered with CONDENSTOP showed no visible changes. As expected, the salt coated steel samples showed significant acceleration of steel deterioration; they were heavily corroded and covered with thick, red-brown, iron-rich rust; the salt coated steel sheets covered with CONDENSTOP however clearly showed significantly less deterioration than the non covered steel samples.

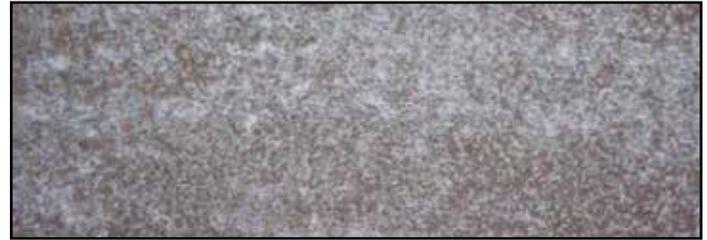
Figure 3. Salt coated steel sample with CONDENSTOP after 500 cycles.
